**Flood Control Project Maintenance  
Levee Inspections**  
**LMA District Cover Sheet**  
**Spring 2009 Levee Inspection Results**

**Reclamation District No. 0150**

**Levee Inspection Report By Mile - Spring 2009**

Waterway	Bank	Unit Miles	Inspection Start/End	Inspector
Unit No. 01 Sutter Slough	Left	0.54	04/08/2009 04/08/2009	David Pesavento

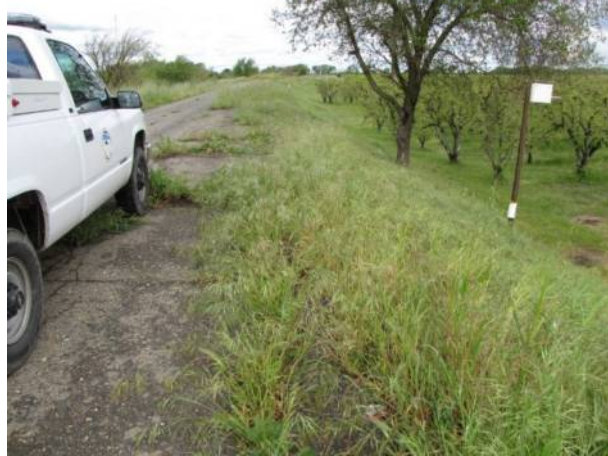
Levee Mile Report Line	1
Start Levee Mile	0.01
End Levee Mile	0.53
Location	Land Side
Category	Earthen Levee
Item	Vegetation
Mow annual grass and weeds prior to fall inspection along the landward slope and 10' beyond.

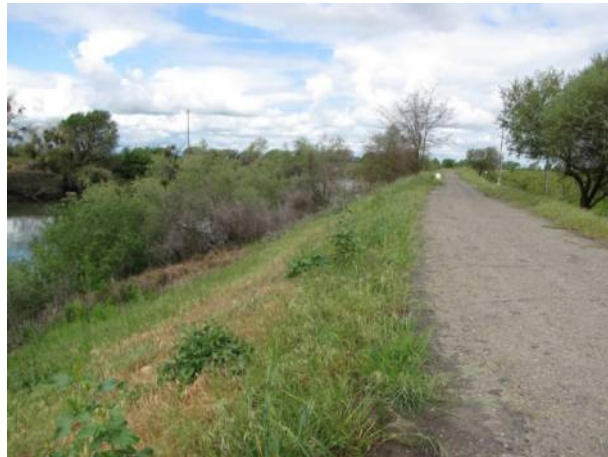
Levee Mile Report Line	2
Start Levee Mile	0.01
End Levee Mile	0.53
Location	Water Side
Category	Earthen Levee
Item	Vegetation
Mow annual grass and weeds prior to fall inspection along the top 20' of the waterward slope.

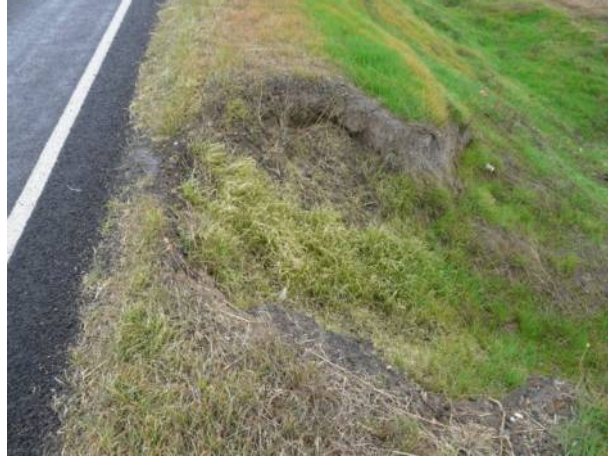
Levee Mile Report Line	1
Start Levee Mile	0.06
End Levee Mile	0.06
Location	Land Side
Category	Earthen Levee
Item	Erosion / Bank Caving
Repair erosion/slumping on landside slope of levee at LM 0.06

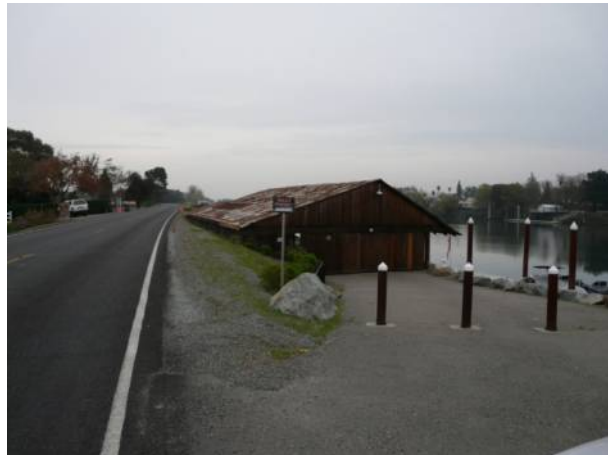
Levee Mile Report Line	2
Start Levee Mile	0.16
End Levee Mile	0.16
Location	Water Side
Category	Earthen Levee
Item	Encroachments
Building located on waterside of levee at LM 0.16

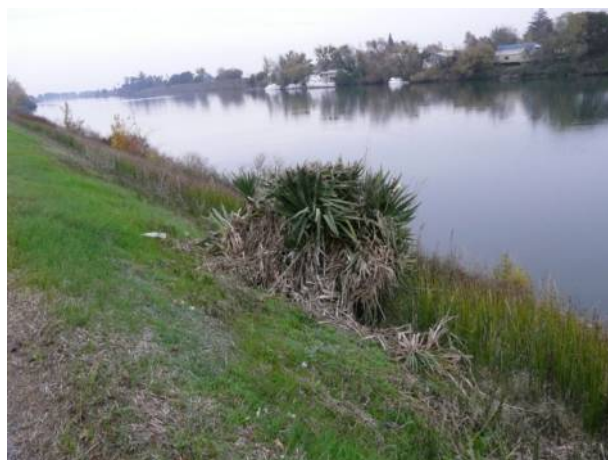
Levee Mile Report Line	3
Start Levee Mile	0.24
End Levee Mile	0.24
Location	Water Side
Category	Earthen Levee
Item	Vegetation
Remove century plant within 20' of waterside shoulder on waterside of the levee at LM 0.24

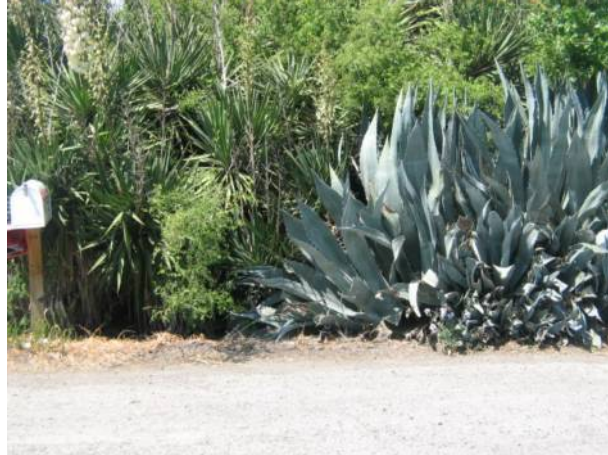
Levee Mile Report Line	4
Start Levee Mile	0.25
End Levee Mile	0.25
Location	Land Side
Category	Earthen Levee
Item	Encroachments
Landscaping on landward slope at LM 0.25 blocking view of levee slope.

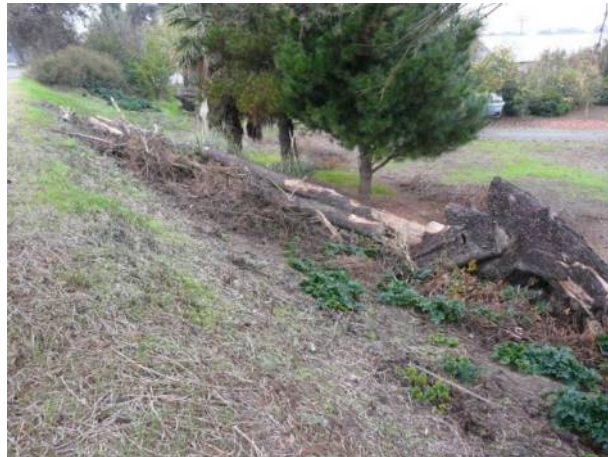
Levee Mile Report Line	5
Start Levee Mile	0.27
End Levee Mile	0.27
Location	Land Side
Category	Earthen Levee
Item	Encroachments
Remove tree branches from landside of levee at LM 0.27

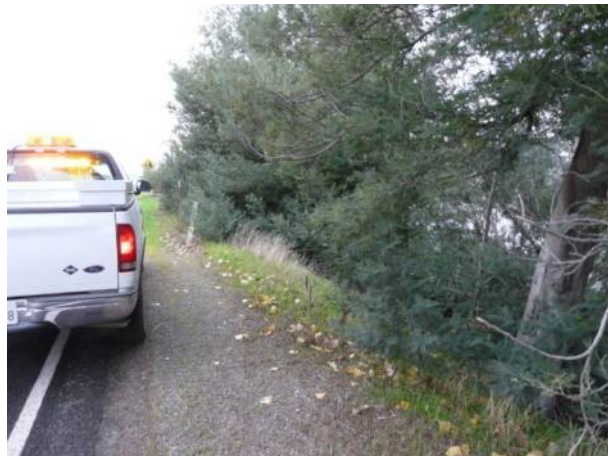
Levee Mile Report Line	8
Start Levee Mile	0.59
End Levee Mile	0.59
Location	Water Side
Category	Earthen Levee
Item	Trim / Thin Trees
Trim trees above 5' from surface of the wateside of the levee within 20' from shoulder at LM 0.59

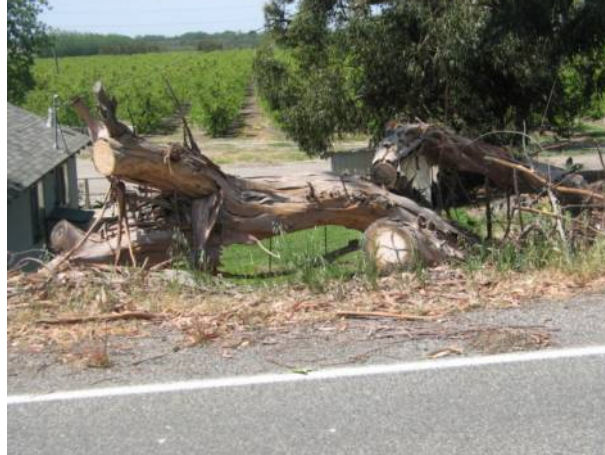
Levee Mile Report Line	24
Start Levee Mile	2.84
End Levee Mile	2.84
Location	Land Side
Category	Earthen Levee
Item	Encroachments
Down tree limbs on landward slope at LM 2.84

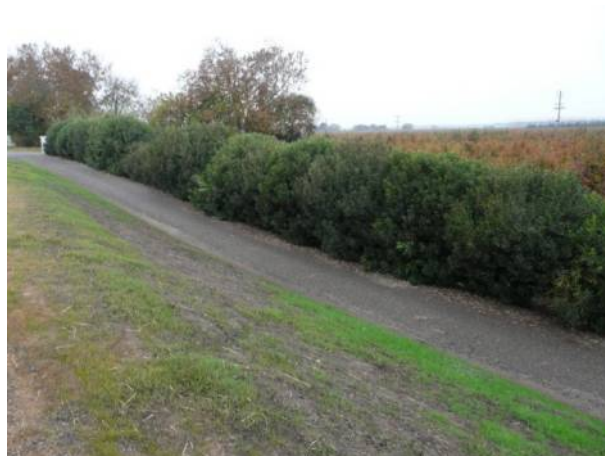
Levee Mile Report Line	25
Start Levee Mile	3.02
End Levee Mile	3.06
Location	Land Side
Category	Earthen Levee
Item	Encroachments
Landscaping providing a screen for a residence on landside of levee from LM 3.02 to LM 3.06

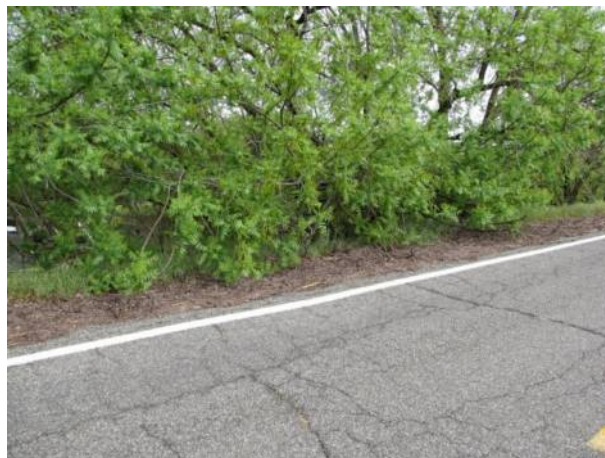
Levee Mile Report Line	26
Start Levee Mile	3.15
End Levee Mile	3.15
Location	Land Side
Category	Earthen Levee
Item	Trim / Thin Trees
Trim trees to 5' above surface of the levee to provide visibility of the landward levee slope at LM 3.15.

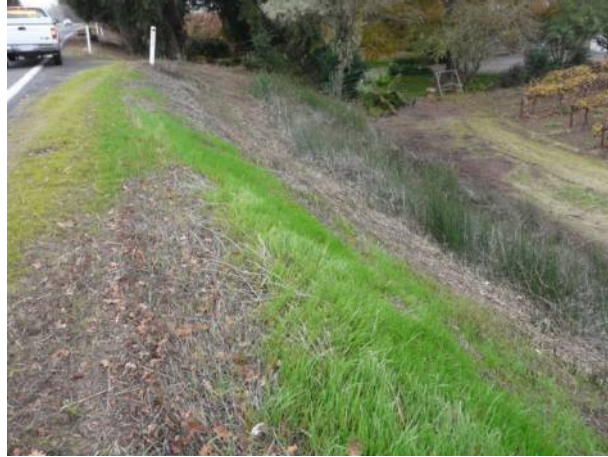
Levee Mile Report Line	30
Start Levee Mile	3.53
End Levee Mile	3.56
Location	Land Side
Category	Earthen Levee
Item	Vegetation
Remove/mow vegetation along landside of levee from LM 3.53 to LM 3.56

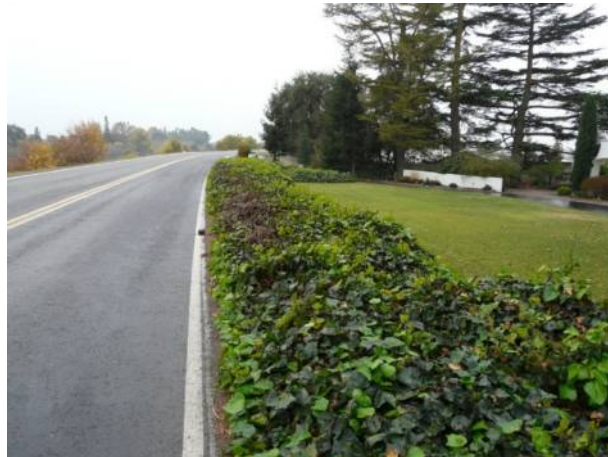
Levee Mile Report Line	33
Start Levee Mile	3.90
End Levee Mile	3.93
Location	Land Side
Category	Earthen Levee
Item	Encroachments
Landscaping in front of a residence on landside of levee from LM 3.90 to LM 3.93. The levee in this location is greater than 100' wide.

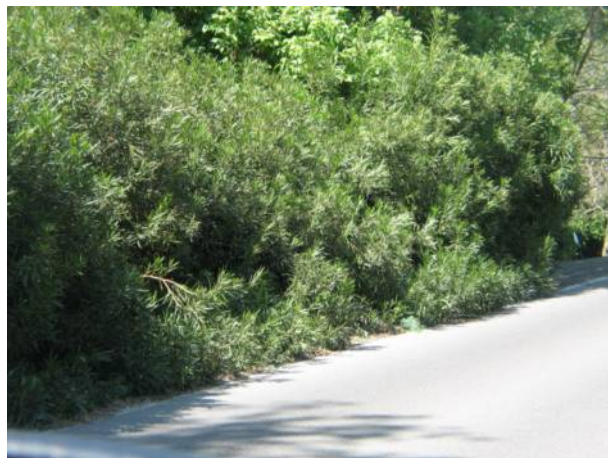
Levee Mile Report Line	35
Start Levee Mile	4.33
End Levee Mile	4.35
Location	Land Side
Category	Earthen Levee
Item	Encroachments
Landscaping (Oleander) on landward slope from 4.33 to 4.35

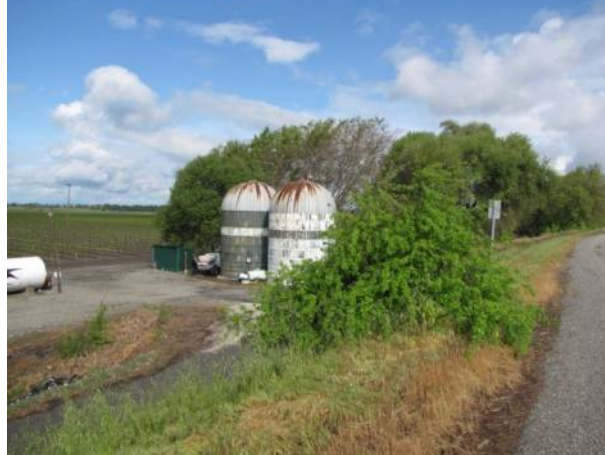
Levee Mile Report Line	37
Start Levee Mile	4.46
End Levee Mile	4.46
Location	Land Side
Category	Earthen Levee
Item	Vegetation
Remove brush to allow visibility of landward levee slope at LM 4.46.

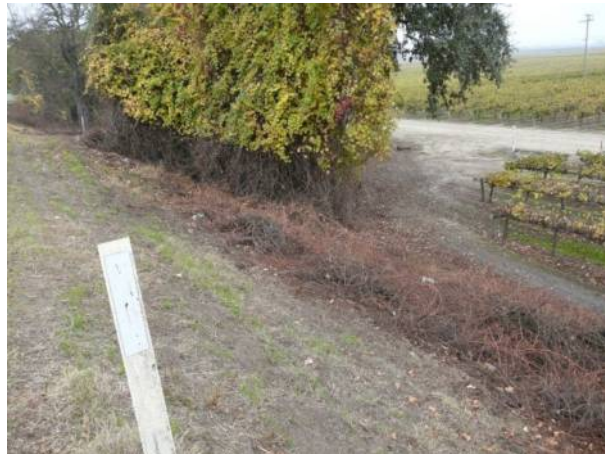
Levee Mile Report Line	39
Start Levee Mile	4.55
End Levee Mile	4.57
Location	Land Side
Category	Earthen Levee
Item	Vegetation
Remove/mow vegetation on landside of levee to allow for visibility from LM 4.55 to LM 4.57

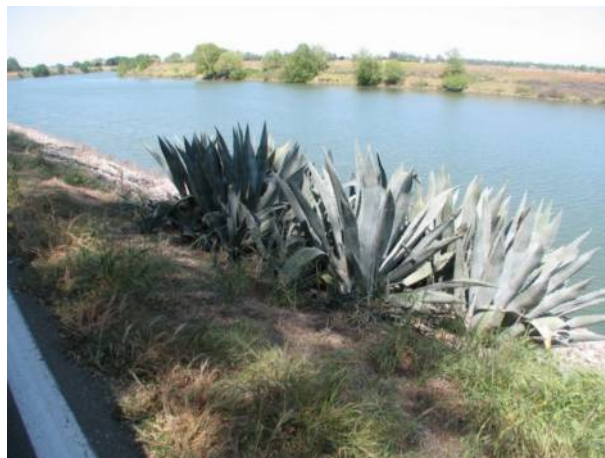
Levee Mile Report Line	41
Start Levee Mile	4.76
End Levee Mile	4.76
Location	Water Side
Category	Earthen Levee
Item	Vegetation
Century plant on waterward slope at LM 4.76

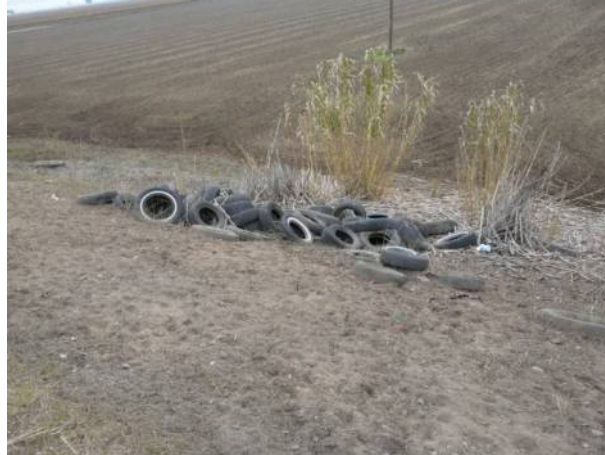
Levee Mile Report Line	51
Start Levee Mile	6.28
End Levee Mile	6.28
Location	Land Side
Category	Earthen Levee
Item	Encroachments
Remove tires from landside of levee at LM 6.28

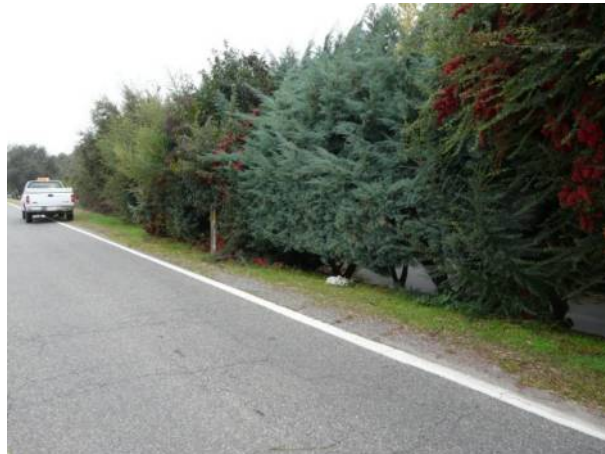
Levee Mile Report Line	59
Start Levee Mile	6.68
End Levee Mile	6.72
Location	Land Side
Category	Earthen Levee
Item	Encroachments
Landscaping providing a screen for a residence on landside of levee from LM 6.68 to LM 6.72

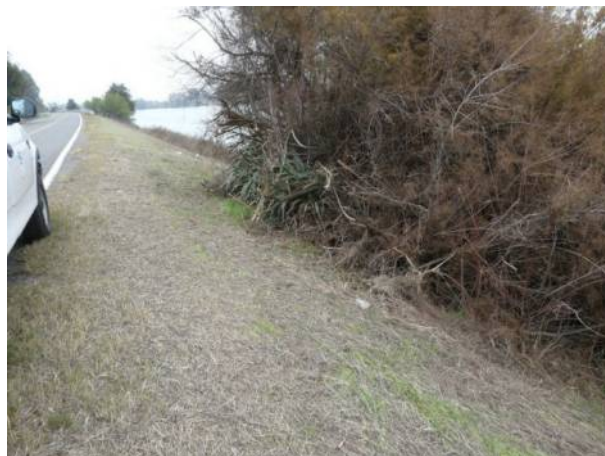
Levee Mile Report Line	60
Start Levee Mile	6.75
End Levee Mile	6.75
Location	Water Side
Category	Earthen Levee
Item	Trim / Thin Trees
Trim/thin trees and brush on waterside of levee within 20' of shoulder to allow visibility at LM 6.75

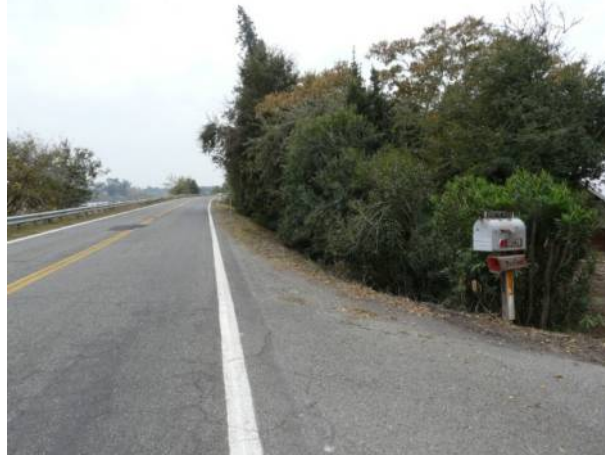
Levee Mile Report Line	65
Start Levee Mile	6.93
End Levee Mile	7.05
Location	Land Side
Category	Earthen Levee
Item	Encroachments
Landscaping providing a screen for a residence on landside of levee from LM 6.93 to LM 7.05

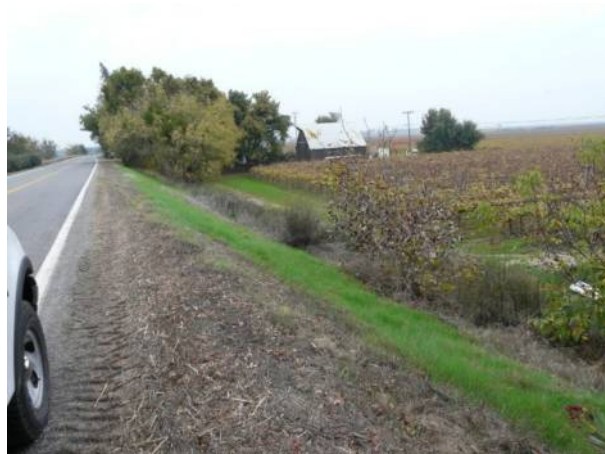
Levee Mile Report Line	66
Start Levee Mile	7.07
End Levee Mile	7.12
Location	Land Side
Category	Earthen Levee
Item	Vegetation
Remove/mow vegetation along bottom of landside slope of levee from LM 7.07 to LM 7.12

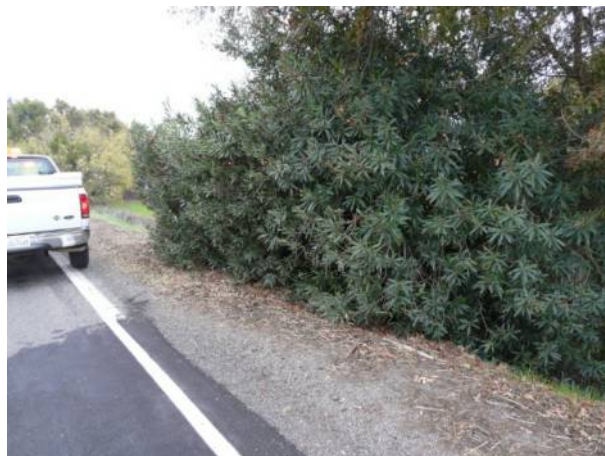
Levee Mile Report Line	67
Start Levee Mile	7.12
End Levee Mile	7.12
Location	Land Side
Category	Earthen Levee
Item	Trim / Thin Trees
Landscaping providing a screen for a residence on landside of levee at LM 7.12

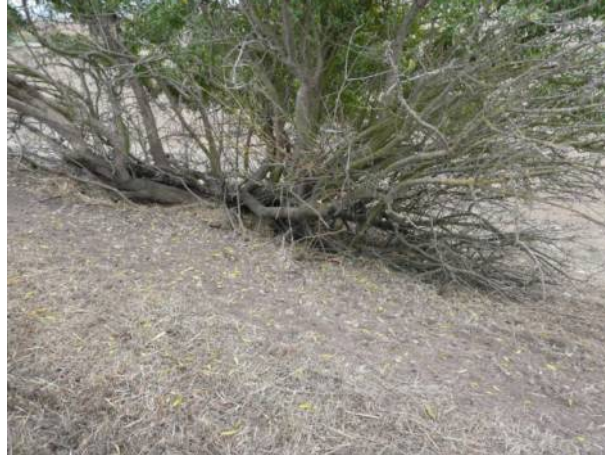
Levee Mile Report Line	69
Start Levee Mile	7.25
End Levee Mile	7.25
Location	Land Side
Category	Earthen Levee
Item	Trim / Thin Trees
Trim or remove brush to allow for visibility on landside of levee at LM 7.25

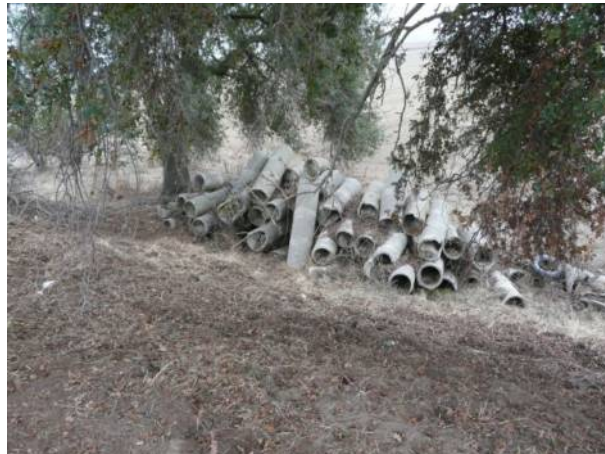
Levee Mile Report Line	70
Start Levee Mile	7.32
End Levee Mile	7.32
Location	Land Side
Category	Earthen Levee
Item	Encroachments
Remove pipes piled on landside of levee to at least 10' from levee toe at LM 7.32

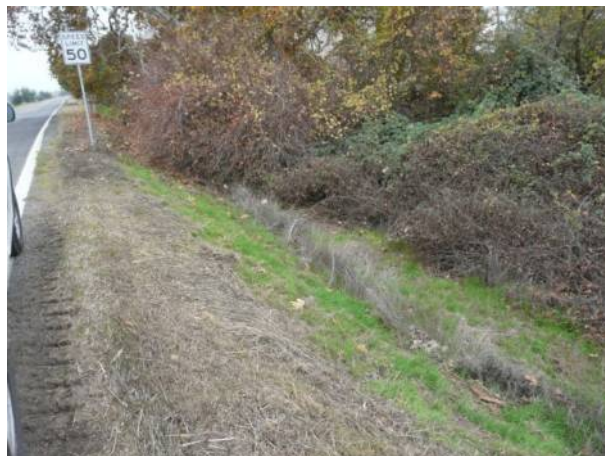
Levee Mile Report Line	71
Start Levee Mile	7.36
End Levee Mile	7.41
Location	Land Side
Category	Earthen Levee
Item	Trim / Thin Trees
Trim/thin trees and brush on landside of levee from LM 7.36 to LM 7.41

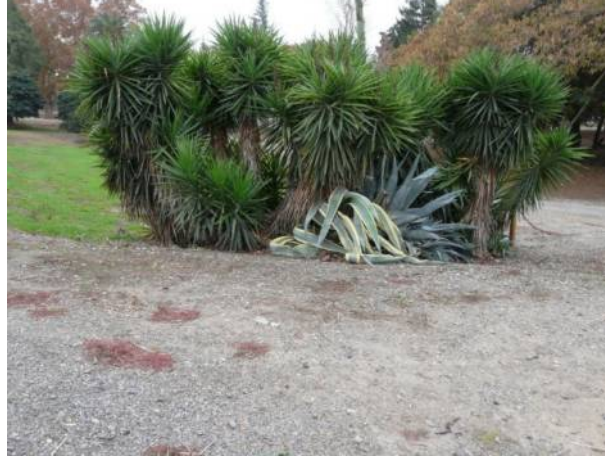
Landscaping on landside of levee at LM 7.92

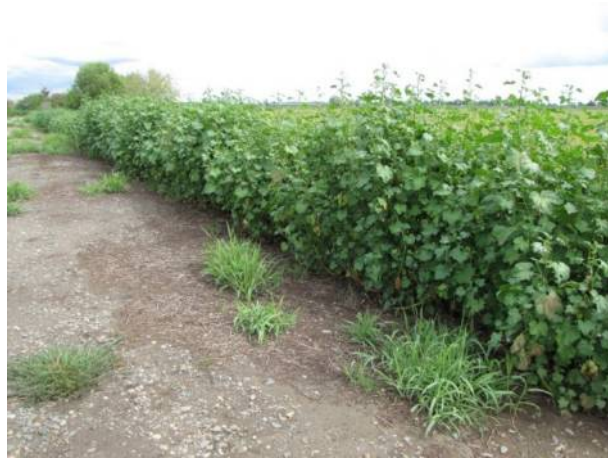
Levee Mile Report Line	3
Start Levee Mile	0.03
End Levee Mile	0.33
Location	Land Side
Category	Earthen Levee
Item	Vegetation
Mow or remove tall (up to 5 feet) vegetation located on landward levee slope completely blocking visibility from LM 0.03 to LM 0.33.

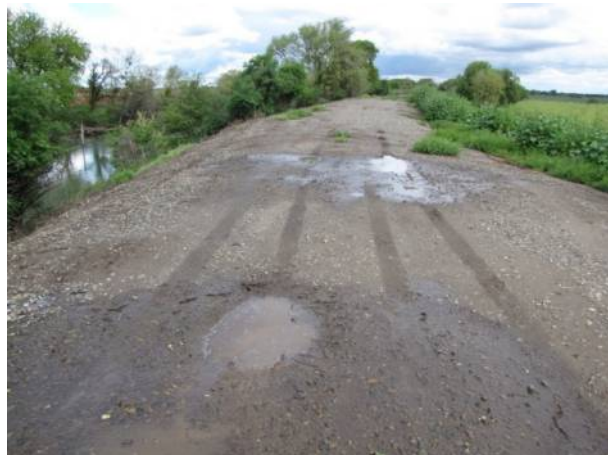
Levee Mile Report Line	4
Start Levee Mile	0.09
End Levee Mile	0.09
Location	Crown
Category	Earthen Levee
Item	Crown Surface / Depressions / Rutting
Re-grade crown access road to remove depressions at LM 0.09.

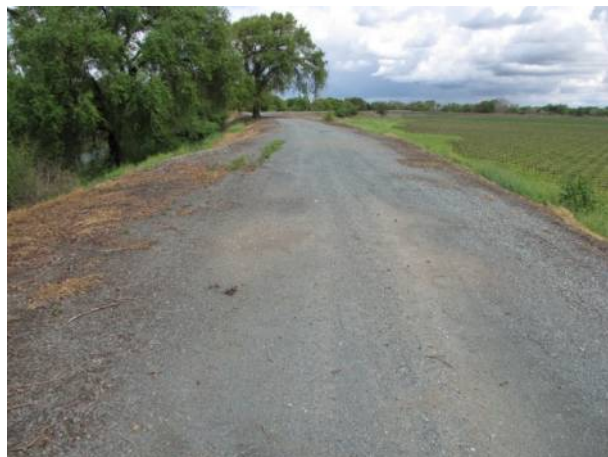
Levee Mile Report Line	8
Start Levee Mile	0.68
End Levee Mile	0.77
Location	Crown
Category	Earthen Levee
Item	Crown Surface / Depressions / Rutting
Good gravel surface of crown access road from LM 0.68 to LM 0.77.

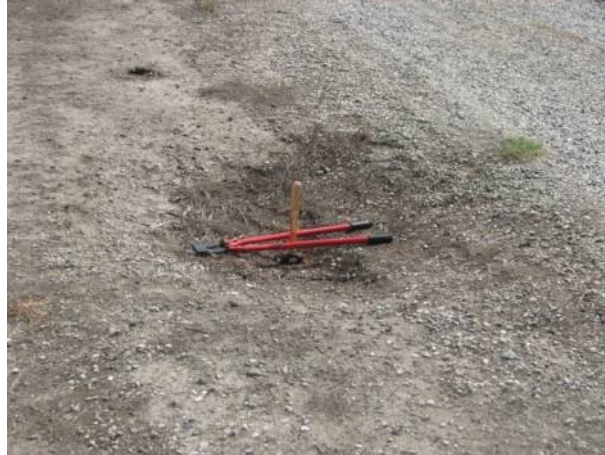
Levee Mile Report Line	11
Start Levee Mile	1.22
End Levee Mile	1.22
Location	Crown
Category	Earthen Levee
Item	Crown Surface / Depressions / Rutting
Minor depression on levee crown at LM 1.22

11	1.22	1.22	Earthen Levee	Crown Surface / Depressions / Rutting	CR	M	Regrade the crown roadway for proper drainage.	38.347613 ° -121.576182 °	38.347613 ° -121.576182 °	Y	9
12	1.23	1.23	Earthen Levee	Slope Stability	LS	M	Repair the levee slope damaged by vehicle traffic and prevent access where possible.	38.347607 ° -121.576130 °	38.347607 ° -121.576130 °	Y	10
13	1.66	1.66	Earthen Levee	Animal Control	LS	M	No rodents visible, but rodent burrows visible; need to backfill and compact or grout borrows.	38.351019 ° -121.572965 °	38.351019 ° -121.572965 °		43
14	2.03	2.06	Earthen Levee	Animal Control	LS	M	No rodents visible, but rodent burrows visible; need to backfill and compact or grout borrows.	38.354792 ° -121.569990 °	38.354689 ° -121.569417 °	Y	44
15	2.84	2.84	Earthen Levee	Encroachments	WS	M	Tree or limb Inspector Comments: Remove fallen tree from top 20' of waterside slope.	38.360210 ° -121.561546 °	38.360210 ° -121.561546 °	Y	924

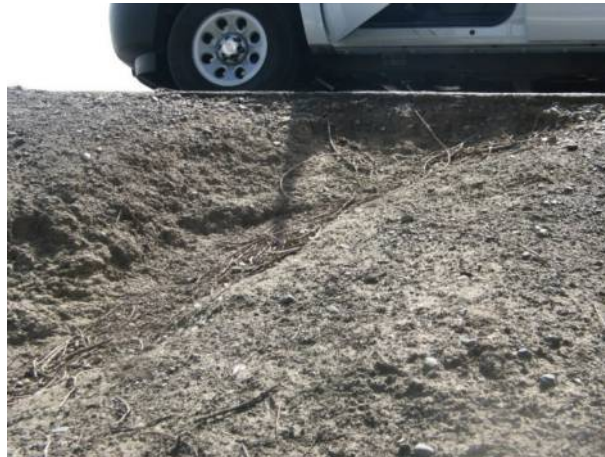
Levee Mile Report Line	12
Start Levee Mile	1.23
End Levee Mile	1.23
Location	Land Side
Category	Earthen Levee
Item	Slope Stability
Damage slope from foot traffic and rain runoff at LM 1.23

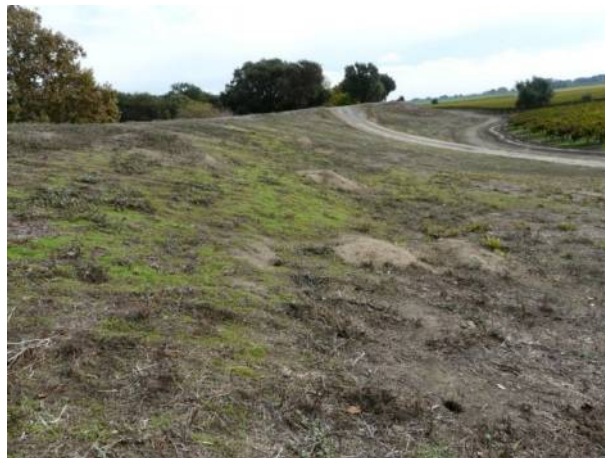
Levee Mile Report Line	14
Start Levee Mile	2.03
End Levee Mile	2.06
Location	Land Side
Category	Earthen Levee
Item	Animal Control
Backfill or grout rodent holes at LM 2.03 to LM 2.06.

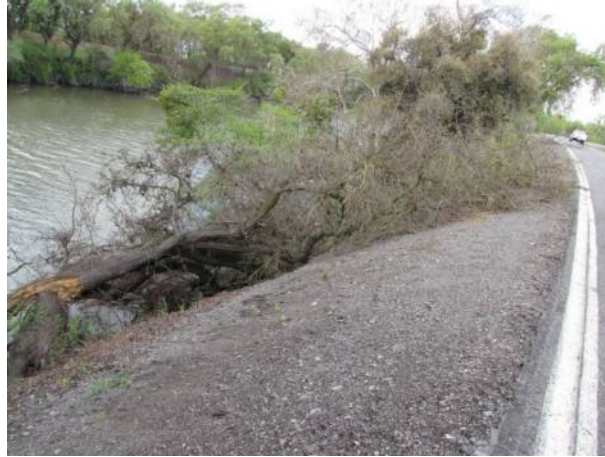
Levee Mile Report Line	15
Start Levee Mile	2.84
End Levee Mile	2.84
Location	Water Side
Category	Earthen Levee
Item	Encroachments
Remove fallen tree blocking visibility/access along top 20' of waterward slope at LM 2.84.

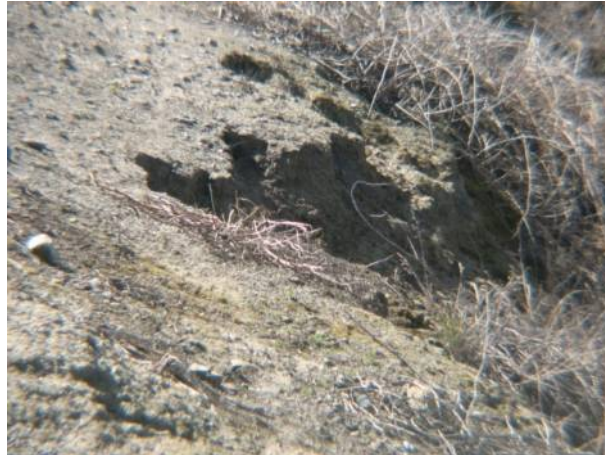
Levee Mile Report Line	18
Start Levee Mile	3.43
End Levee Mile	3.48
Location	Water Side
Category	Earthen Levee
Item	Erosion / Bank Caving
Erosion damage on waterward toe from LM 3.43 to 3.48

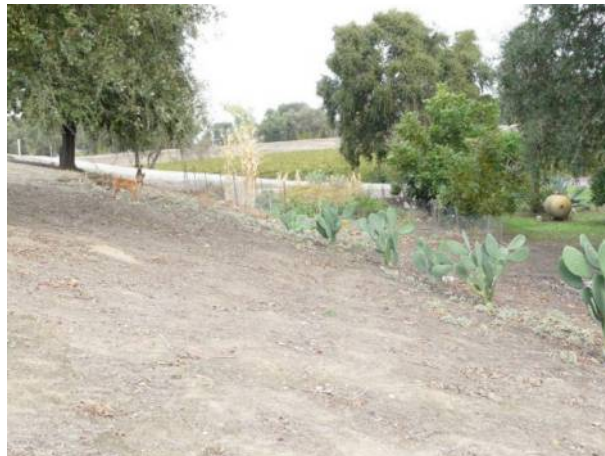
Levee Mile Report Line	19
Start Levee Mile	3.50
End Levee Mile	3.54
Location	Land Side
Category	Earthen Levee
Item	Encroachments
Landscaping & garden on landward slope of levee at LM 3.50 to LM 3.54.

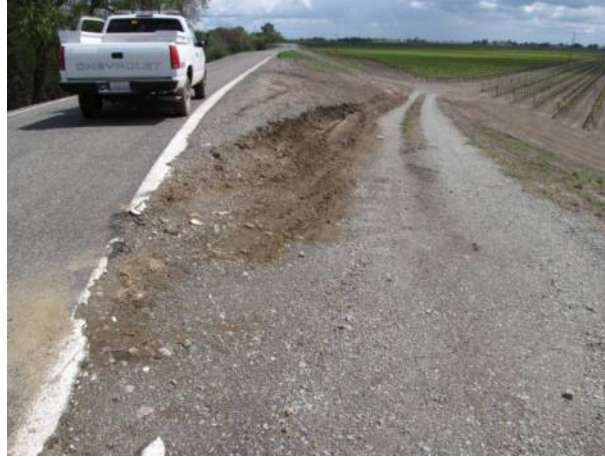
Levee Mile Report Line	20
Start Levee Mile	3.75
End Levee Mile	3.75
Location	Land Side
Category	Earthen Levee
Item	Slope Stability
Repair minor damage to levee slope along landward ramp at LM 3.75.

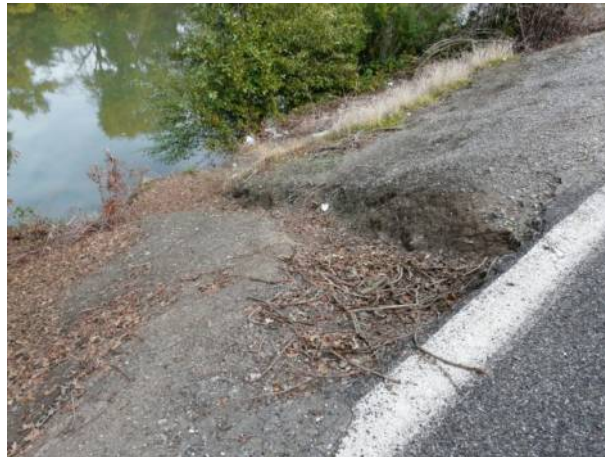
Levee Mile Report Line	21
Start Levee Mile	3.77
End Levee Mile	3.77
Location	Water Side
Category	Earthen Levee
Item	Slope Stability
Repair slope damaged by foot traffic at LM 3.77.

21	3.77	3.77	Earthen Levee	Slope Stability	WS	M	Repair the levee slope damaged by foot traffic and prevent access where possible.	38.367393 ° -121.554528 °	38.367393 ° -121.554528 °	Y	15
22	3.95	3.95	Earthen Levee	Encroachments	LS	M	Debris	38.368118 ° -121.551509 °	38.368118 ° -121.551509 °	Y	48
23	4.38	4.38	Earthen Levee	Animal Control	LS	M	No rodents visible, but rodent burrows visible; need to backfill and compact or grout borrows.	38.373649 ° -121.550542 °	38.373649 ° -121.550542 °		50
24	4.46	4.46	Earthen Levee	Encroachments	LS	M	Prunings	38.374269 ° -121.549385 °	38.374269 ° -121.549385 °	Y	51
25	4.51	4.51	Earthen Levee	Encroachments	LS	M	Debris	38.374267 ° -121.548441 °	38.374267 ° -121.548441 °		52
26	4.55	4.58	Earthen Levee	Encroachments	LS	PO	Landscaping	38.374311 ° -121.547802 °	38.374368 ° -121.547263 °	Y	16
27	4.59	4.59	Earthen Levee	Trim / Thin Trees	WS	M	Trim and thin trees to allow visibility of the ground and room to flood fight.	38.374419 ° -121.547096 °	38.374419 ° -121.547096 °	Y	53

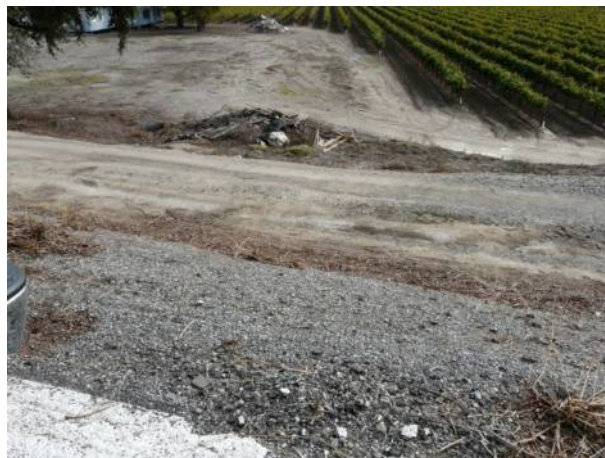
Levee Mile Report Line	22
Start Levee Mile	3.95
End Levee Mile	3.95
Location	Land Side
Category	Earthen Levee
Item	Encroachments
Debris pile on landward slope at LM 3.95.

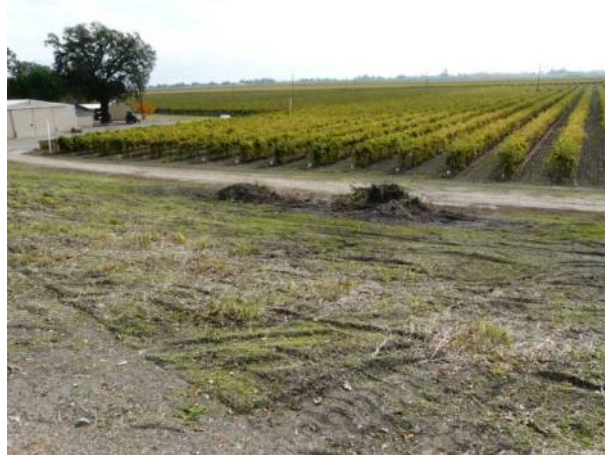
Levee Mile Report Line	24
Start Levee Mile	4.46
End Levee Mile	4.46
Location	Land Side
Category	Earthen Levee
Item	Encroachments
Remove pruning pile on landward slope at LM 4.46.

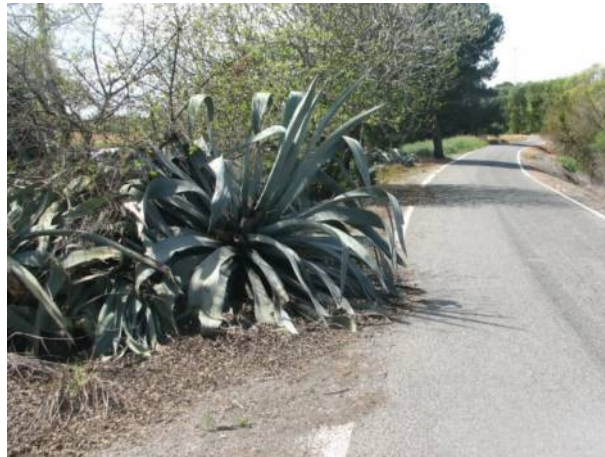
Levee Mile Report Line	26
Start Levee Mile	4.55
End Levee Mile	4.58
Location	Land Side
Category	Earthen Levee
Item	Encroachments
Landscaping blocking view of landward slope from 4.50 to 4.58

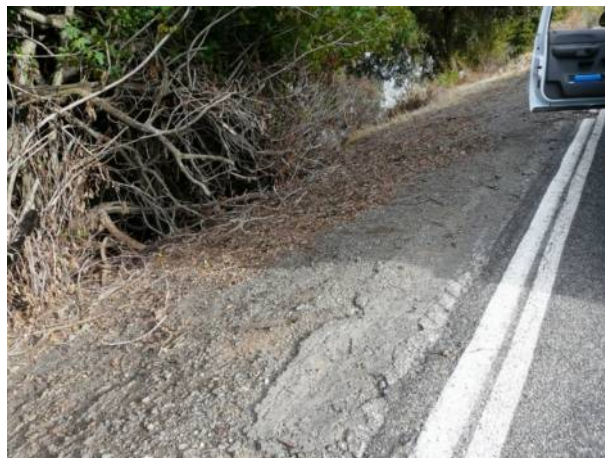
Levee Mile Report Line	27
Start Levee Mile	4.59
End Levee Mile	4.59
Location	Water Side
Category	Earthen Levee
Item	Trim / Thin Trees
Thin/trim trees to allow for the top 20' waterward slope of levee to be seen at LM 4.59.

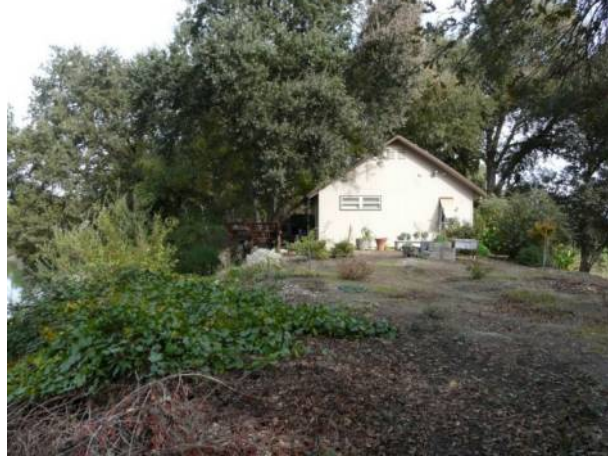
Building & associated landscaping on levee crown at LM 5.93.

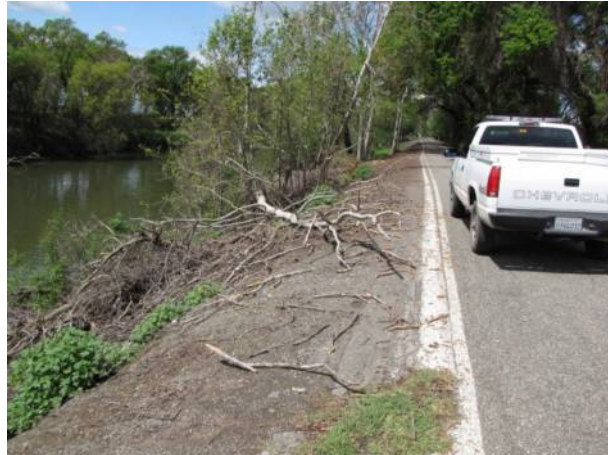
Levee Mile Report Line	36
Start Levee Mile	6.10
End Levee Mile	6.10
Location	Water Side
Category	Earthen Levee
Item	Encroachments

Remove fallen tree branch from top 20' of waterward levee slope at LM 6.10.

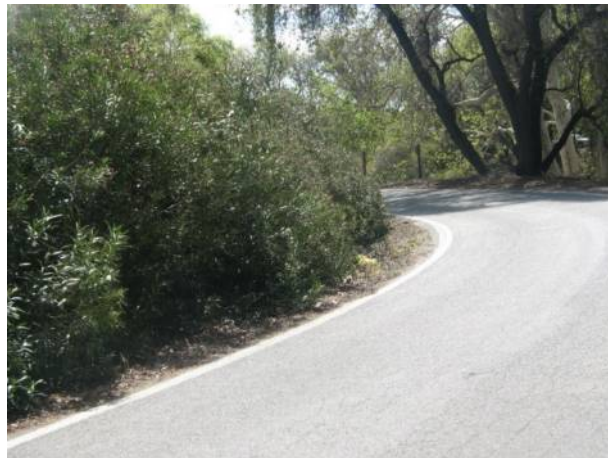
Levee Mile Report Line	38
Start Levee Mile	6.24
End Levee Mile	6.31
Location	Land Side
Category	Earthen Levee
Item	Encroachments

Oleander on landward slope blocking view of levee from LM 6.24 to 6.32

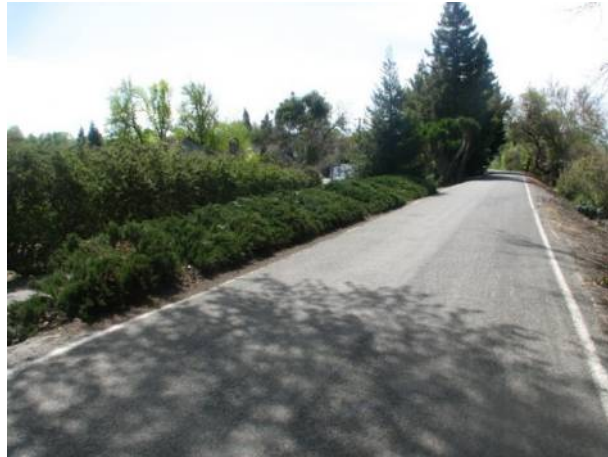
Levee Mile Report Line	40
Start Levee Mile	6.37
End Levee Mile	6.40
Location	Land Side
Category	Earthen Levee
Item	Encroachments
Landscaping on landward slope blocking view from LM 6.37 to 6.40

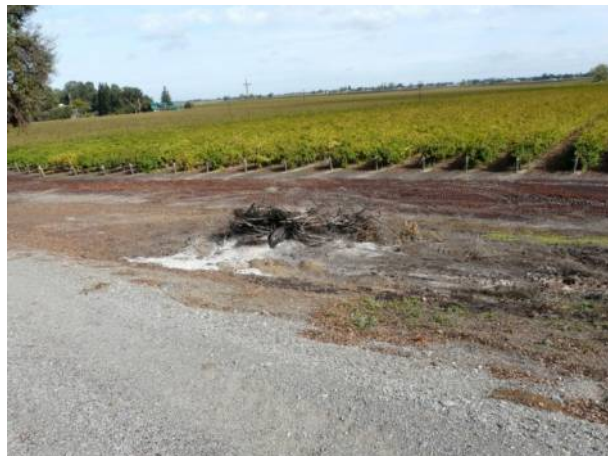
Levee Mile Report Line	43
Start Levee Mile	6.65
End Levee Mile	6.65
Location	Land Side
Category	Earthen Levee
Item	Encroachments
Remove debris from landward slope at LM 6.65.

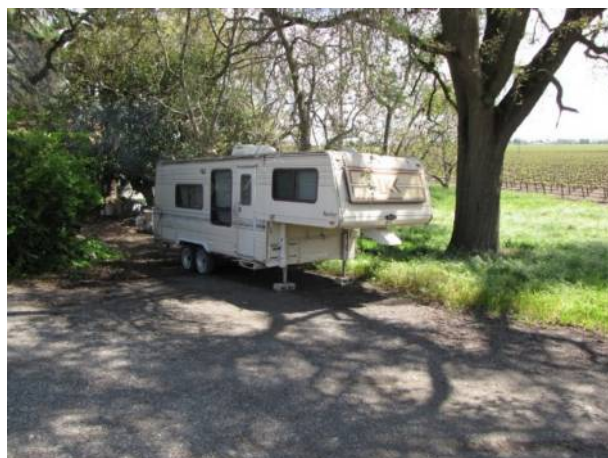
Levee Mile Report Line	45
Start Levee Mile	6.86
End Levee Mile	6.86
Location	Land Side
Category	Earthen Levee
Item	Encroachments
Remove Camper trailer parked along landard ramp at LM 6.86 and place a minimum of 10' from the toe of the levee.

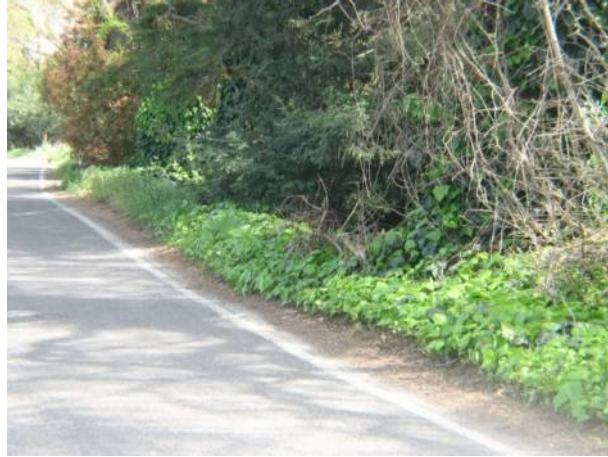
Levee Mile Report Line	47
Start Levee Mile	6.87
End Levee Mile	6.95
Location	Land Side
Category	Earthen Levee
Item	Encroachments
Landscaping on landward slope blocking view from LM 6.87 to 6.95

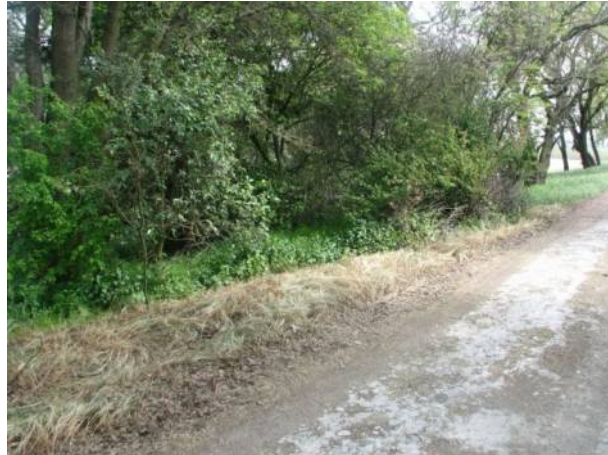
Levee Mile Report Line	52
Start Levee Mile	7.42
End Levee Mile	7.44
Location	Land Side
Category	Earthen Levee
Item	Encroachments
Landscaping on landward slope blocking view from LM 7.42 to 7.47

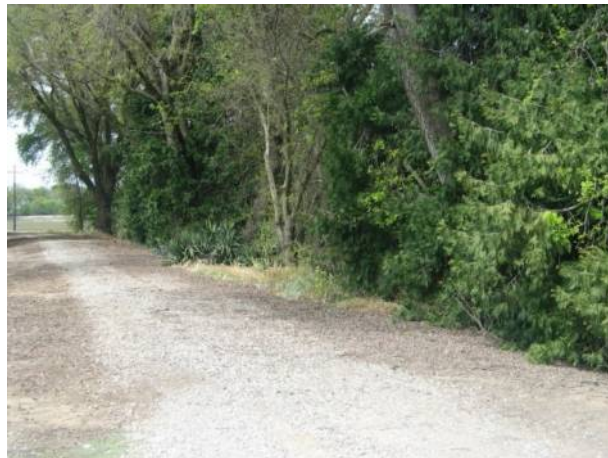
Levee Mile Report Line	55
Start Levee Mile	7.55
End Levee Mile	7.55
Location	Land Side
Category	Earthen Levee
Item	Encroachments
Landscaping on landward slope blocking view from LM 7.52 to 7.58

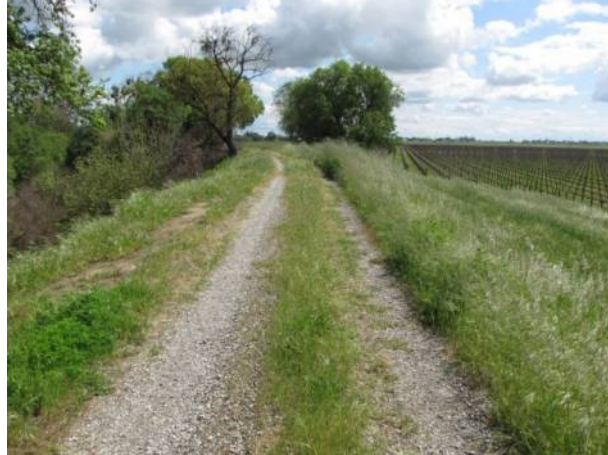
Levee Mile Report Line	59
Start Levee Mile	8.35
End Levee Mile	9.54
Location	Crown
Category	Earthen Levee
Item	Vegetation
Remove all vegetation from the crown of the levee from LM 8.35 to 9.54 to provide visibility and to allow for vehicular access without risk of fire.

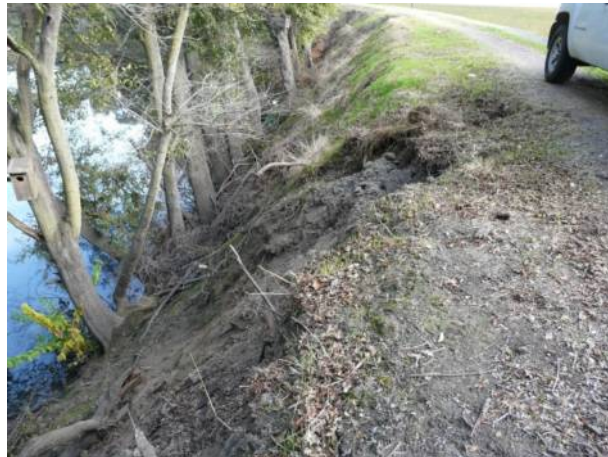
Levee Mile Report Line	60
Start Levee Mile	8.46
End Levee Mile	8.46
Location	Water Side
Category	Earthen Levee
Item	Erosion / Bank Caving
Repair erosion on waterward slope near shoulder at LM 8.46.

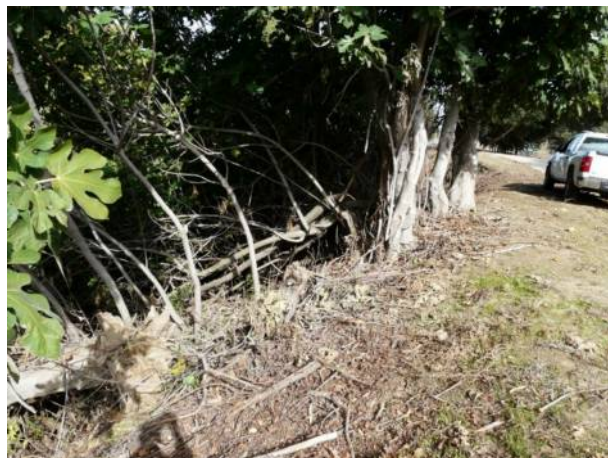
Levee Mile Report Line	68
Start Levee Mile	9.51
End Levee Mile	9.51
Location	Water Side
Category	Earthen Levee
Item	Trim / Thin Trees
Thin/trim trees to allow for visibility of top 20' of waterward slope at LM 9.51.
